VW Transporter T5 T6 7H - Multivan 7E

Multifunction Steering Wheel Retrofit Wiring Harness

These instructions are for retrofitting a multifunction steering wheel (MFSW).

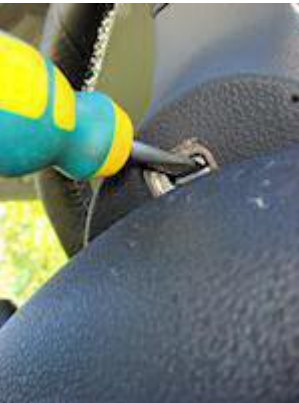
Use a flathead screwdriver to lever the retaining loop around the stud on the steering wheel. Simultaneously, pull from the edge of the airbag towards you.

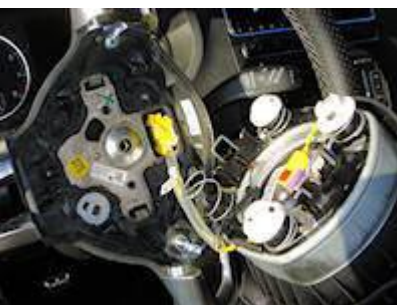
Hold the airbag in your other hand to prevent it hanging from the wiring. Undo the yellow connector that goes to the slip ring. Pull the white locking piece towards you to free the connector.

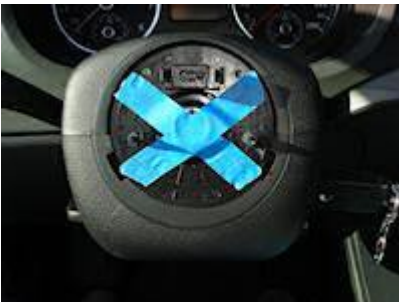
Now you can see the airbag slip ring that makes all the electrical connections to the steering wheel. Avoid spinning the slip ring, otherwise you might lose its central position, which could lead to the ribbon cable getting destroyed the next time you turn the steering to full lock. Use tape to "lock" the slip ring to this central position.

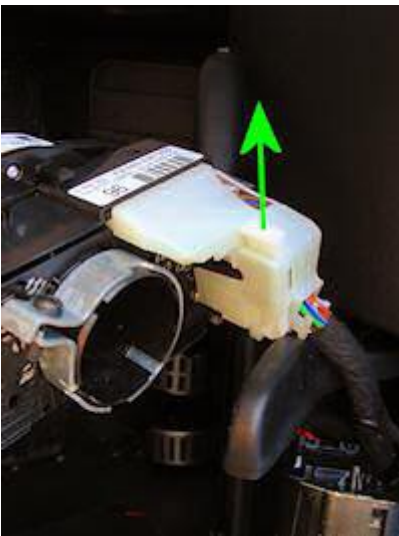
Undo the connector T41 at the slip ring / stalk switch. There's a locking to the connector: lift up the locking rod as indicated by the green arrow.

In the picture, the slip ring / stalk switch unit is removed from the **steering** column for ease of access to the connector. Should you want to do the same, just loosen the Torx screw (T25) on the metal tightening collar, and the unit can be pulled away from the **steering** column.

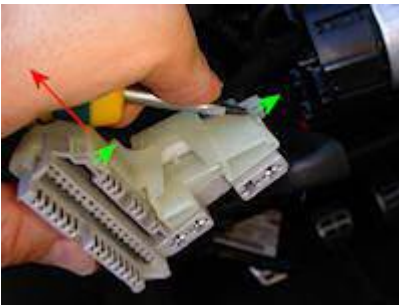
Remove the connector cover: Prise up the locking tabs indicated by the green arrows, and simultaneously pull the cover to the direction indicated by the red arrow.

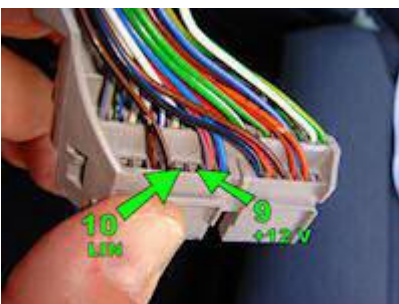
Under the cover you can see the individual wire positions in the connector body. You'll need to add the ends of the repair wires to positions 9 and 10 indicated by the arrows.

- Position 9: +12V
- Position 10: LIN bus

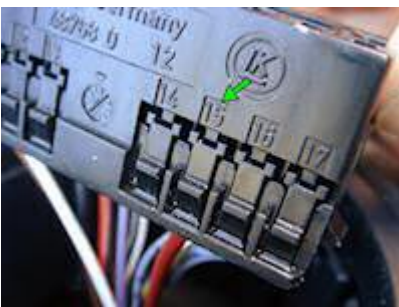
The required constant +12V is found at pin 15.

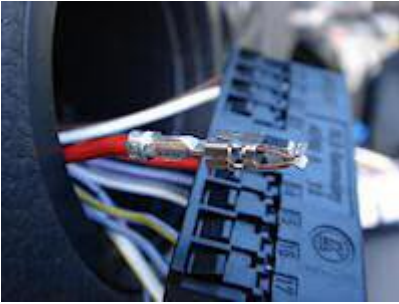
The pin freed. You can see the small locking tabs you need to push down for the pin to come out.

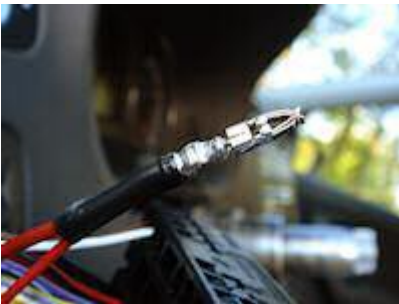
The new wire soldered to the base of the pin. Try to make the join as thin as possible, otherwise you may have trouble getting the pin to fit back into the connector body. Be careful not to destroy the dashboard with the hot soldering iron!

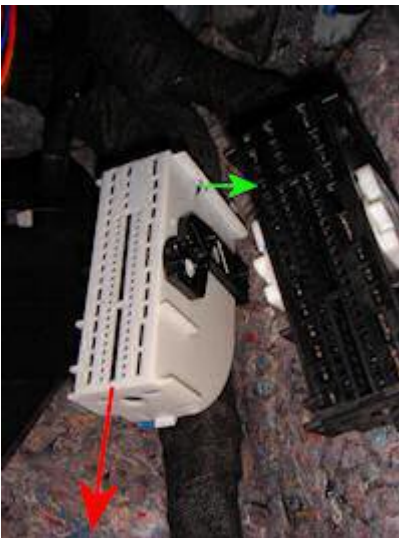
The connector cover is removed by spreading the locking tabs on both sides in the direction of the green arrow, while simultaneously pulling the cover in the direction of the red arrow.

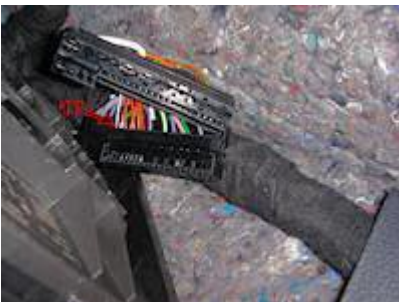
Under the cover is the connector body with two halves. You'll need to slide the halves apart to get access to the pin 17 situated in one of the inner rows. The wire in question is violet-white in colour.

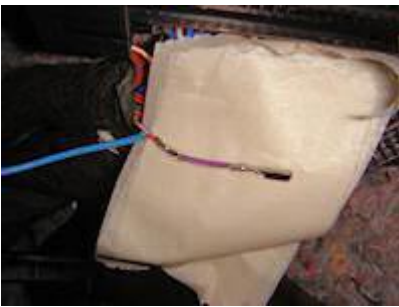
Wrap the new wire coming from the slip ring / stalk switch unit pin 10 around the violet-white wire. Solder it, again careful not to damage anything with the hot soldering iron.

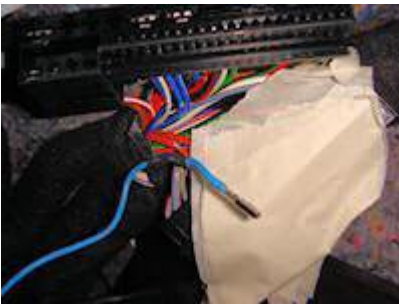
Insulate the connection with shrink tubing. Don't run the tubing all the way to the pin as in the picture: I had trouble get the pin to fit into the connector body so had to cut away some of the tubing.

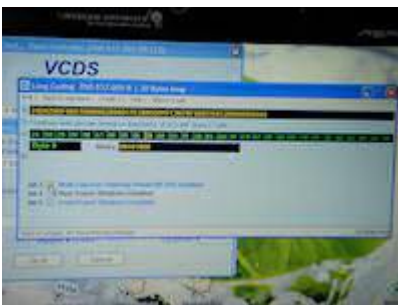
Find the checkbox "Multi-Function-**Steering-Wheel** (MFSW) installed" and check that. For this particular CECM it was Byte 9 Bit 3.

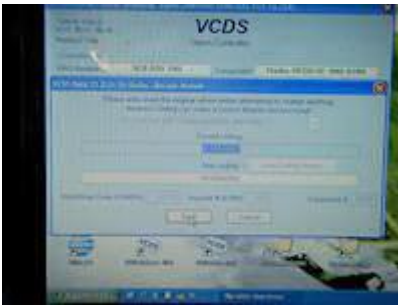
For the RCD510, Byte 3 Bit 0 is "Shortpress **Steering Wheel** Buttons installed". Check that.
